Overview of Testing Results for Lead in Drinking Water and Corrective Actions for Portsmouth Naval Shipyard Building 342 Child Development Center (CDC) and Building H10 Youth Center (YC)

Priority Areas Lead Testing and Corrective Actions Portsmouth Naval Shipyard Child Development Center and Youth Center Buildings 342 and H10

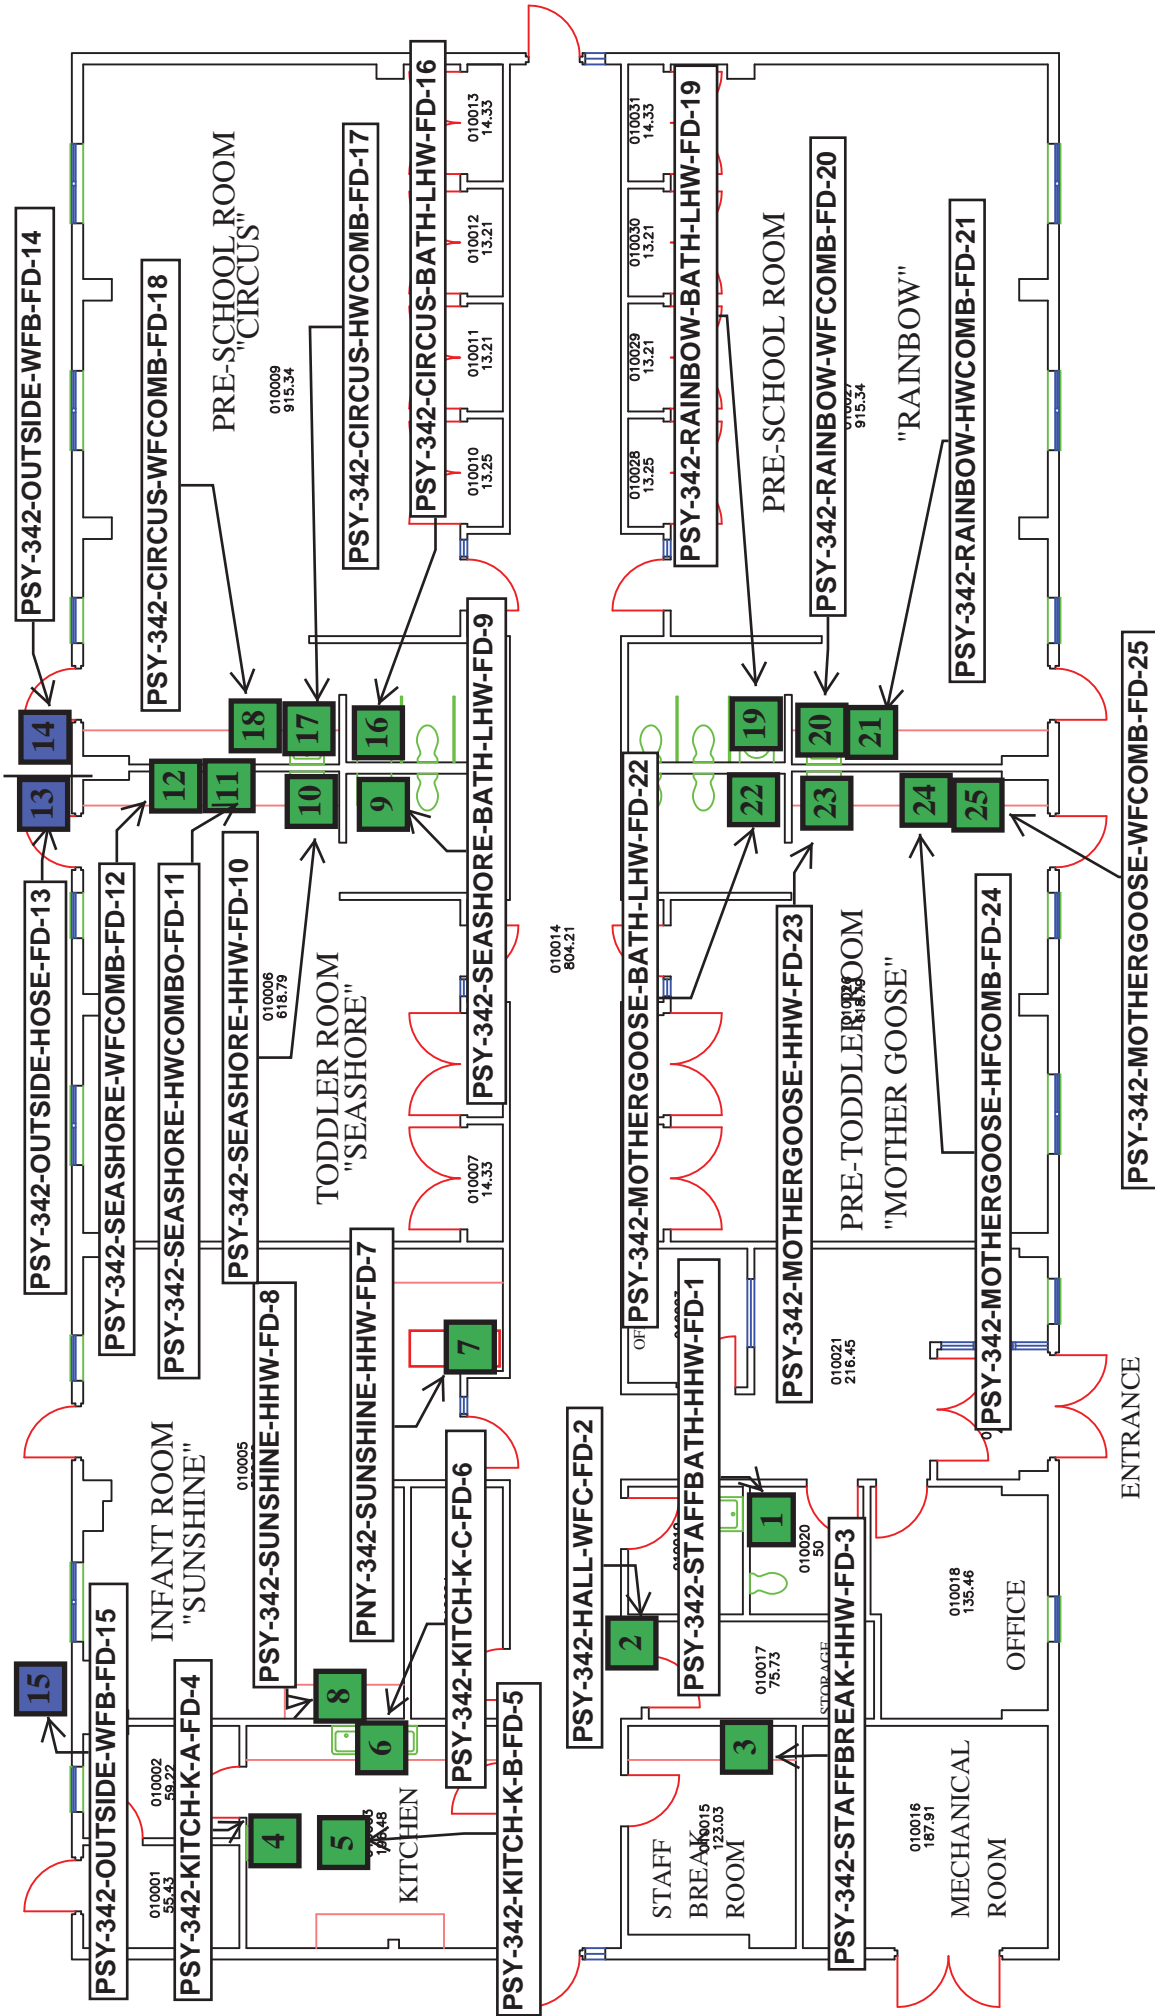
1 BUILDING 342 - FIRST FLOOR PLAN

- **3 OUTSIDE OUTLETS NOT SAMPLED**
- **22 INTERIOR OUTLETS SAMPLED – ALL TESTED < 20 PPB**

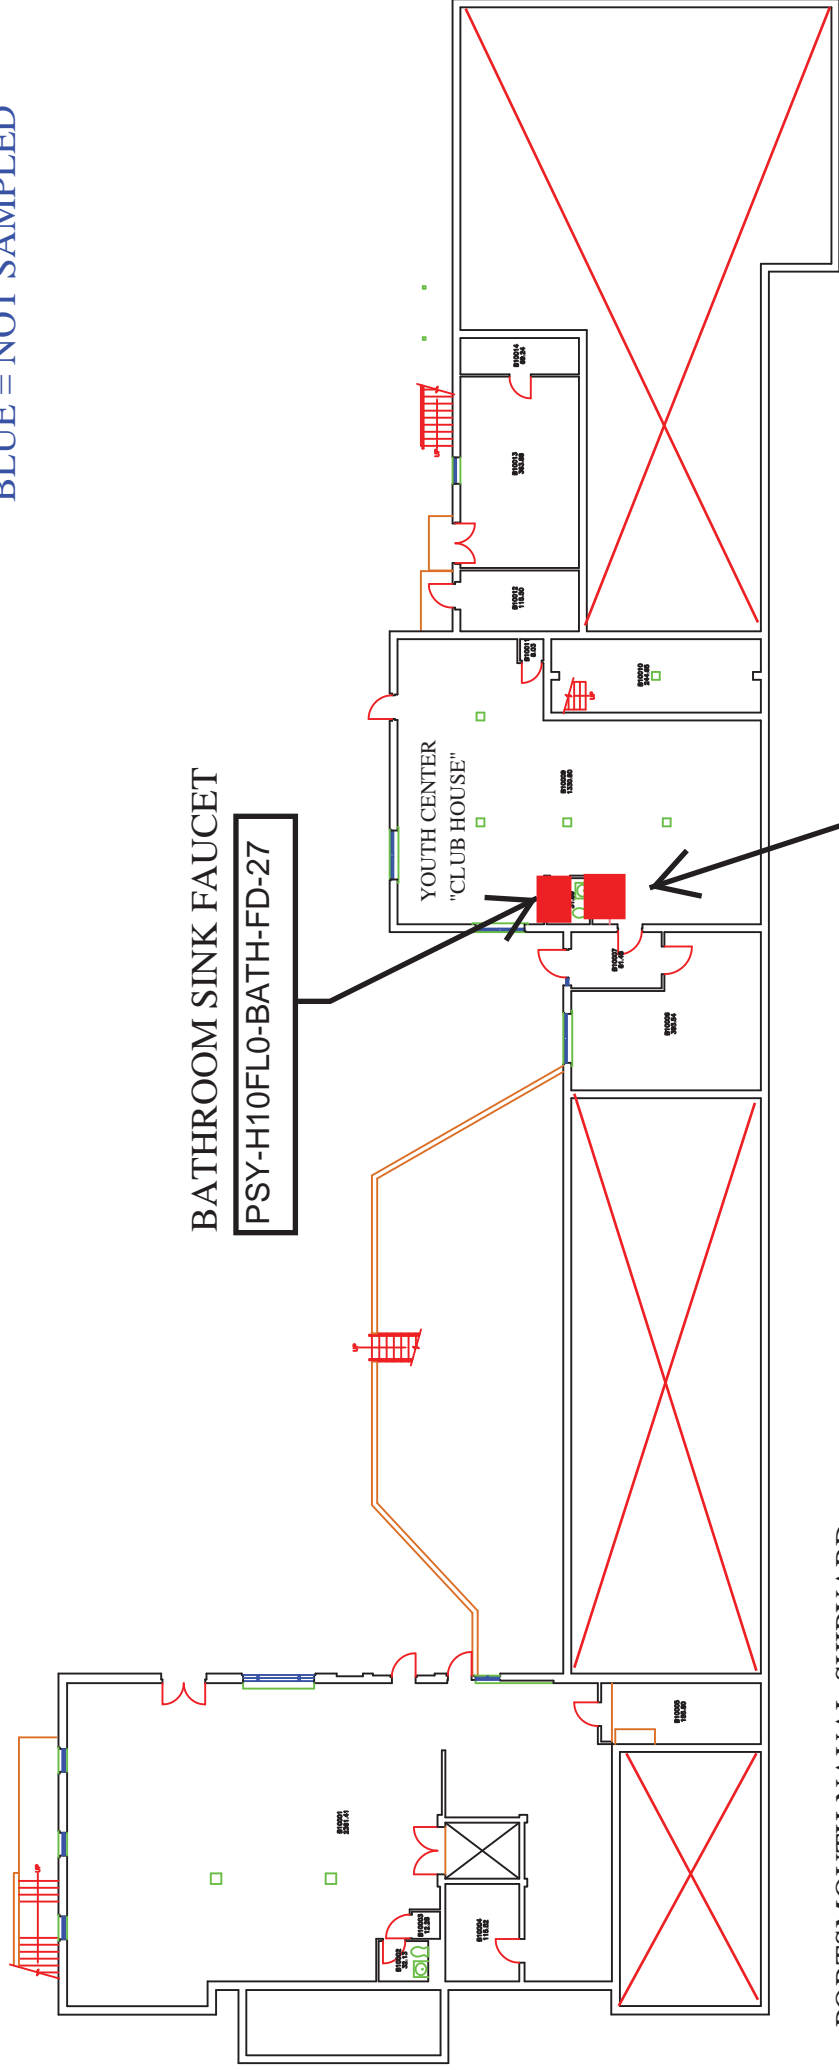
BUILDING H10 YOUTH CENTER (CURRENTLY NOT IN USE)
 FLOOR 0 - BASEMENT LEVEL

Two outlets exceeding the EPA-recommended level are in a currently unused area called the “Club House” located on the basement floor of the building. In this area, the kitchen sink faucet tested at 30 ppb and the bathroom faucet tested at 22 ppb. The third exceedance was found in the women’s bathroom sink located on the second floor outside of the theater room. This bathroom is occasionally used by youth for hand washing when movies are shown in the theater.

Follow-up sampling at these three outlets was conducted after inspecting the faucets. Prior to resampling, the aerators were removed and replaced from the two “Club House” faucets; retesting showed that the sink faucet in the bathroom was below the EPA-recommended level while the kitchen faucet remained above 20 ppb. A **faucet aerator** (or tap aerator) is often

- **FLOOR 0 (BASEMENT LEVEL): 2 OUTLETS SAMPLED; BOTH > 20 PPB**
- **FLOOR 1 (YOUTH CENTER): 5 OUTLETS SAMPLED; ALL < 20 PPB**
- **FLOOR 2 (THEATER AREA): 3 OUTLETS SAMPLED; 1 > 20 PPB AND 2 < 20 PPB**

- If the lead concentration of the 30 second flush sample resulted in lower than 20 ppb lead, the aerator was the source of lead and the outlet can be used for drinking if the aerator is cleaned or replaced. ***The sink in the YC Club House bathroom fits in this category. This aerator has been replaced.***

- If the lead concentration of the resampled first draw (but not the follow up 30 second flush) was greater than 20 ppb, the fixture was the source of lead. These fixtures can be used if water is flushed for 30 seconds before first use of the day or if the fixtures are replaced and retesting confirms that the new fixtures do not leach lead. ***The Club House kitchen sink (basement floor) and the women's bathroom sink (second floor) are in this category. The faucets and shut off valves are being replaced.***

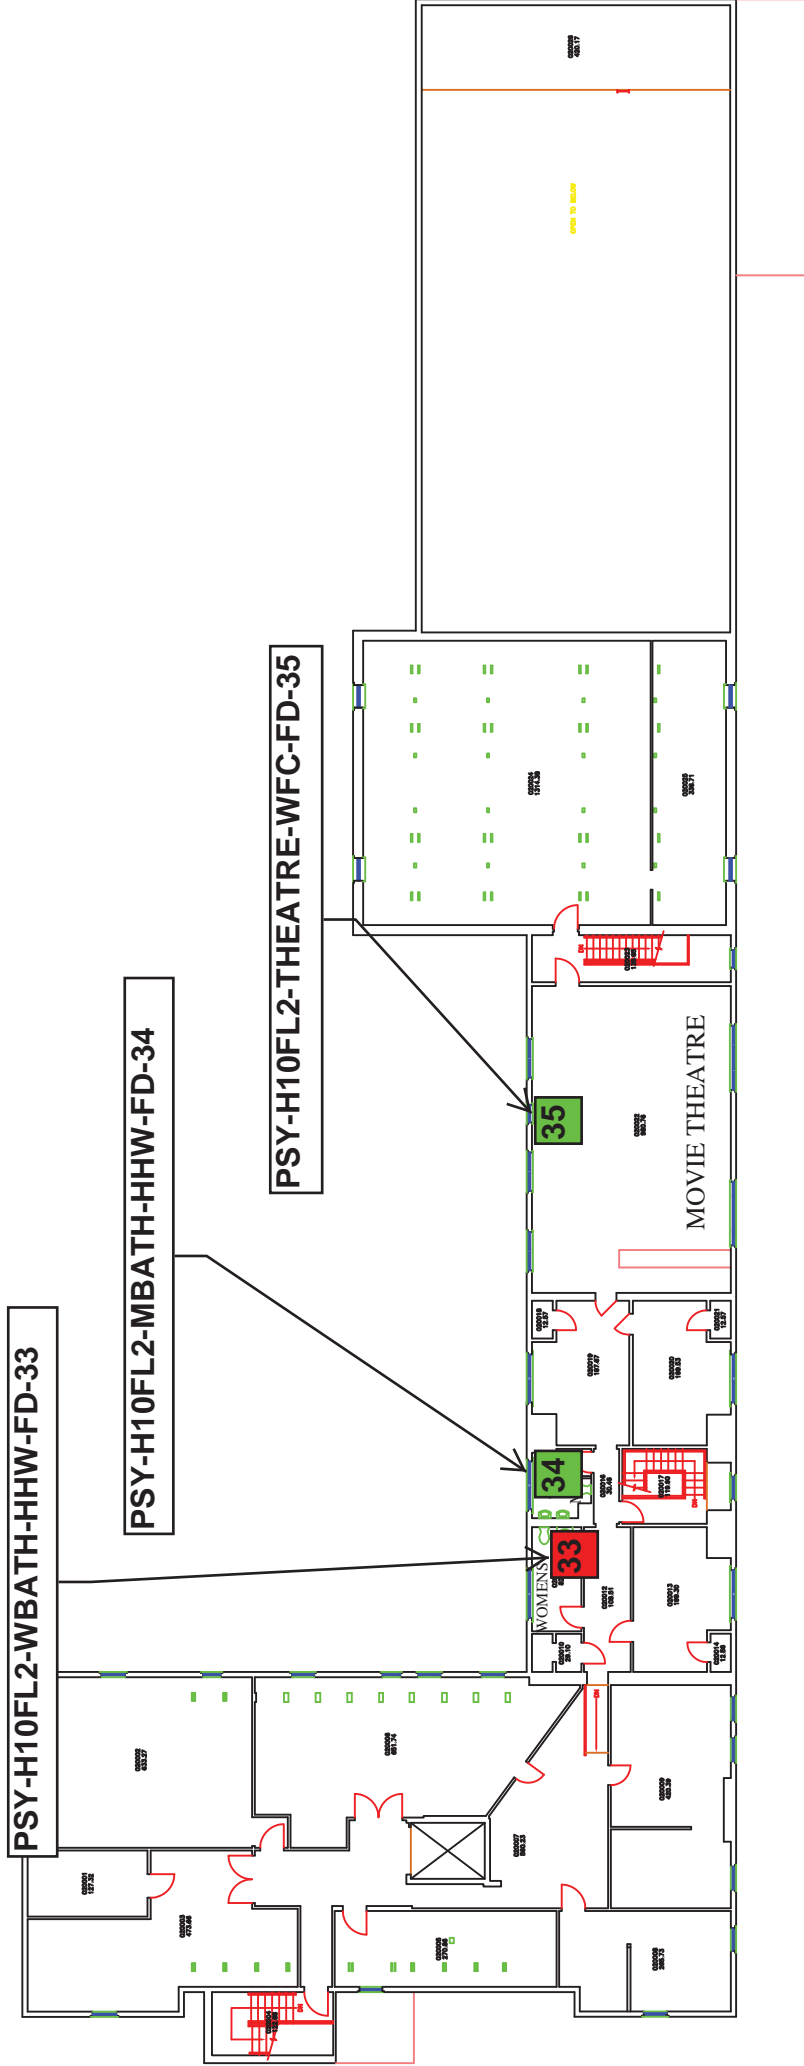
BUILDING H10 YOUTH CENTER
FLOOR TWO

The women's bathroom sink on the second floor had no aerator and was retested without one. Resampling results showed this faucet to remain above 20 ppb. A copy of all test results is enclosed for your information. The test results are presented in two tables:
