Overview of Testing Results and Corrective Actions for Lead in Drinking Water Naval Submarine Base New London Child Development Center and Youth Center

Priority Areas Lead Testing and Corrective Actions - DECEMBER 2018
SUBASENLON Child Development Center
CT186, CT383, CT386

NAVY YOUTH CENTER DRINKING WATER TESTING
29 HICKORY DRIVE, GROTON, CT 06340
DECEMBER 2018

NAVY YOUTH CENTER ADDITION DRINKING WATER TESTING
29 HICKORY DRIVE, GROTON, CT 06340
DECEMBER 2018

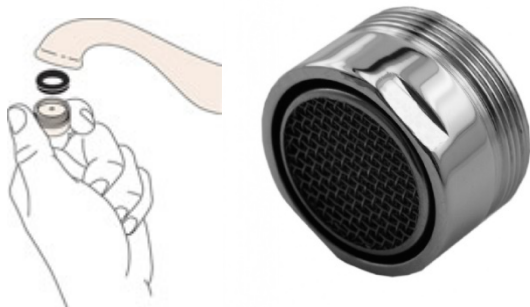
It should be noted that **faucet aerators** (or tap aerators) are commonly found at the tip of modern indoor water faucets to help save water and reduce splashing and these are also used at the CDC and YC. However, caution must be used as the aerator and screen can trap debris which can accumulate lead. In order to maintain drinking water quality in the CDC and YC, Navy policy mandates that all aerators used at these facilities be checked and cleaned regularly. CDC staff and the Public Works Department at SUBASENLON work together to ensure that all aerators used at the CDC and YC are maintained in strict accordance with the Navy policy.

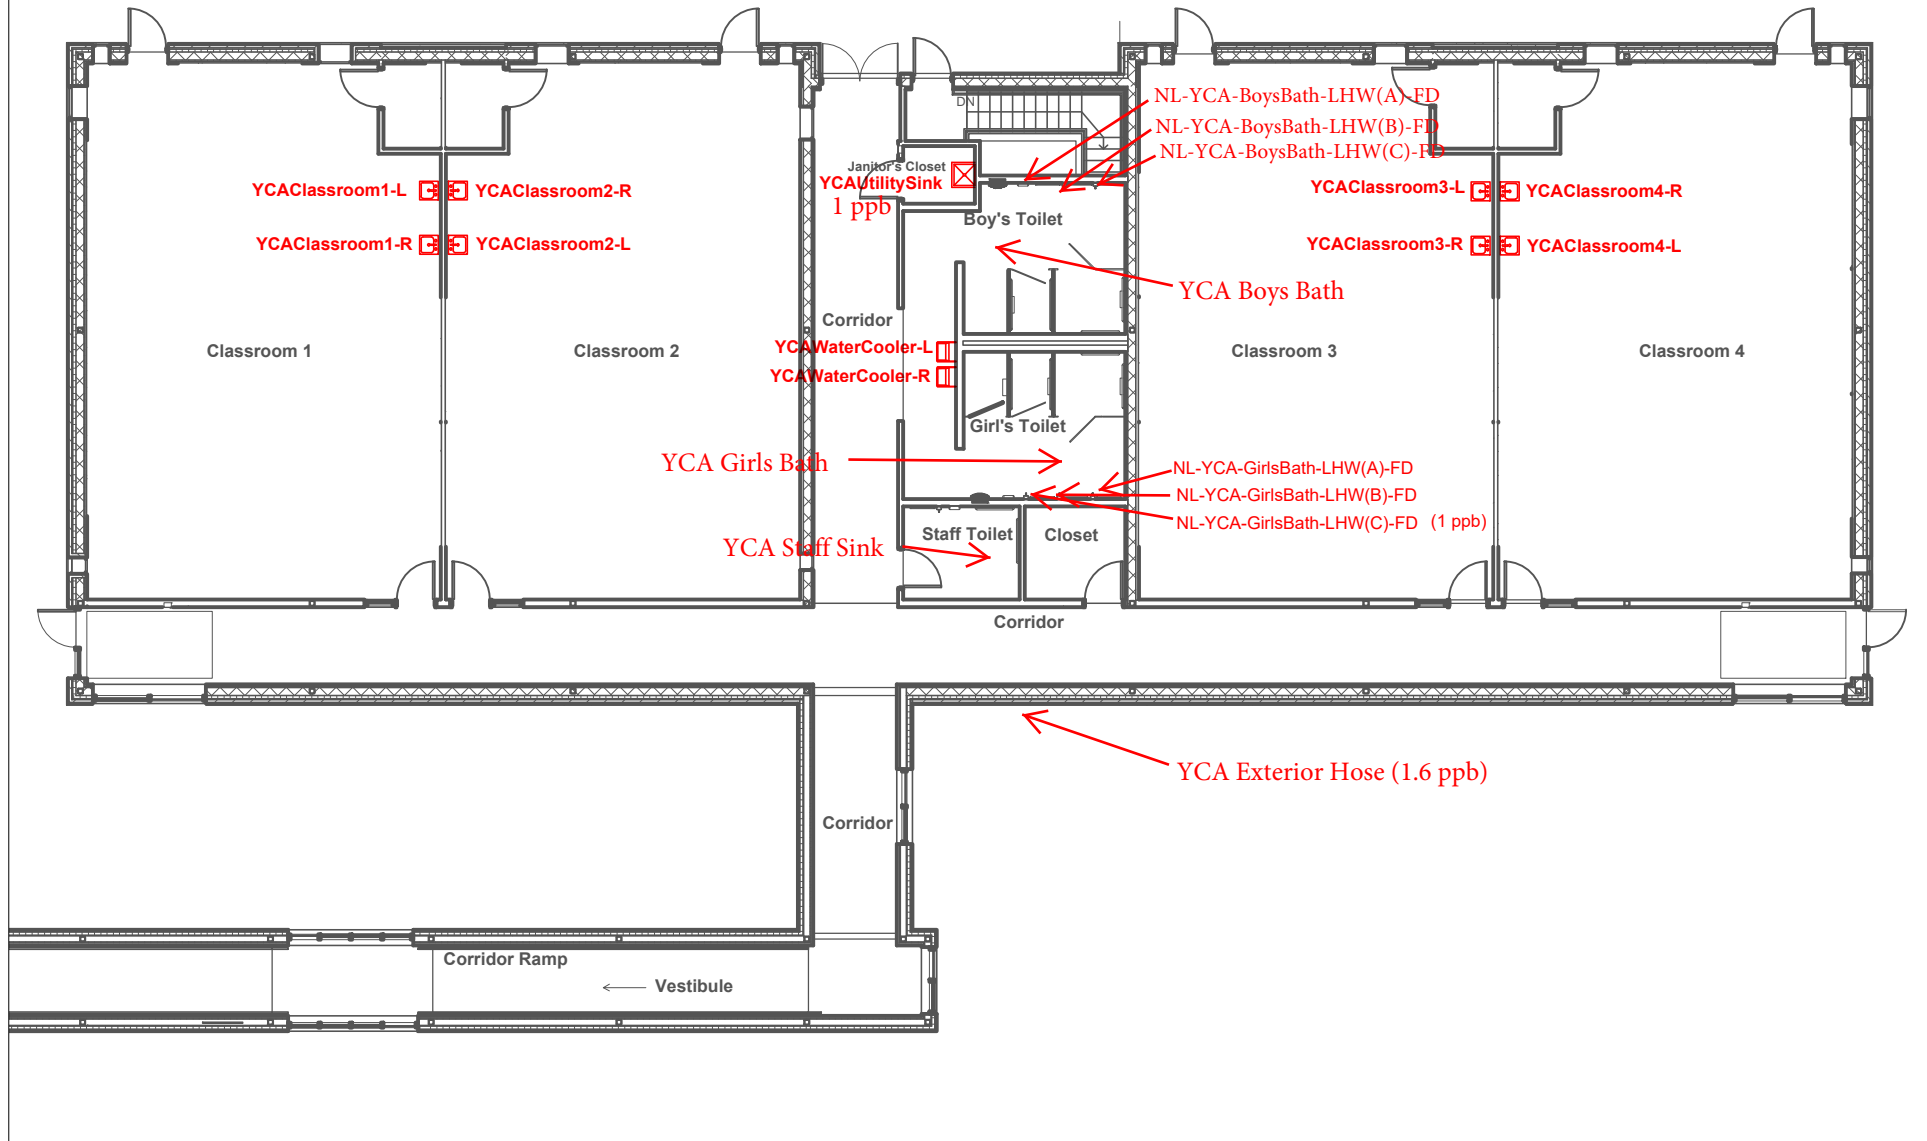
YOUTH CENTER ADDITION (CH905)

NAVY PRIORITY AREA WATER TESTING PROGRAM - DEC 2018

SAMPLING LOCATIONS

NOTE: All lead results <1 ppb except as noted.
