## Testing Results for Lead in Drinking Water for Norfolk Naval Shipyard – Gosport Child Development Center - Buildings 1641-1642

Priority Areas Lead Testing and Corrective Actions (October 2014)  
Norfolk Naval Shipyard Gosport Child Development Center  
Buildings 1641 and 1642

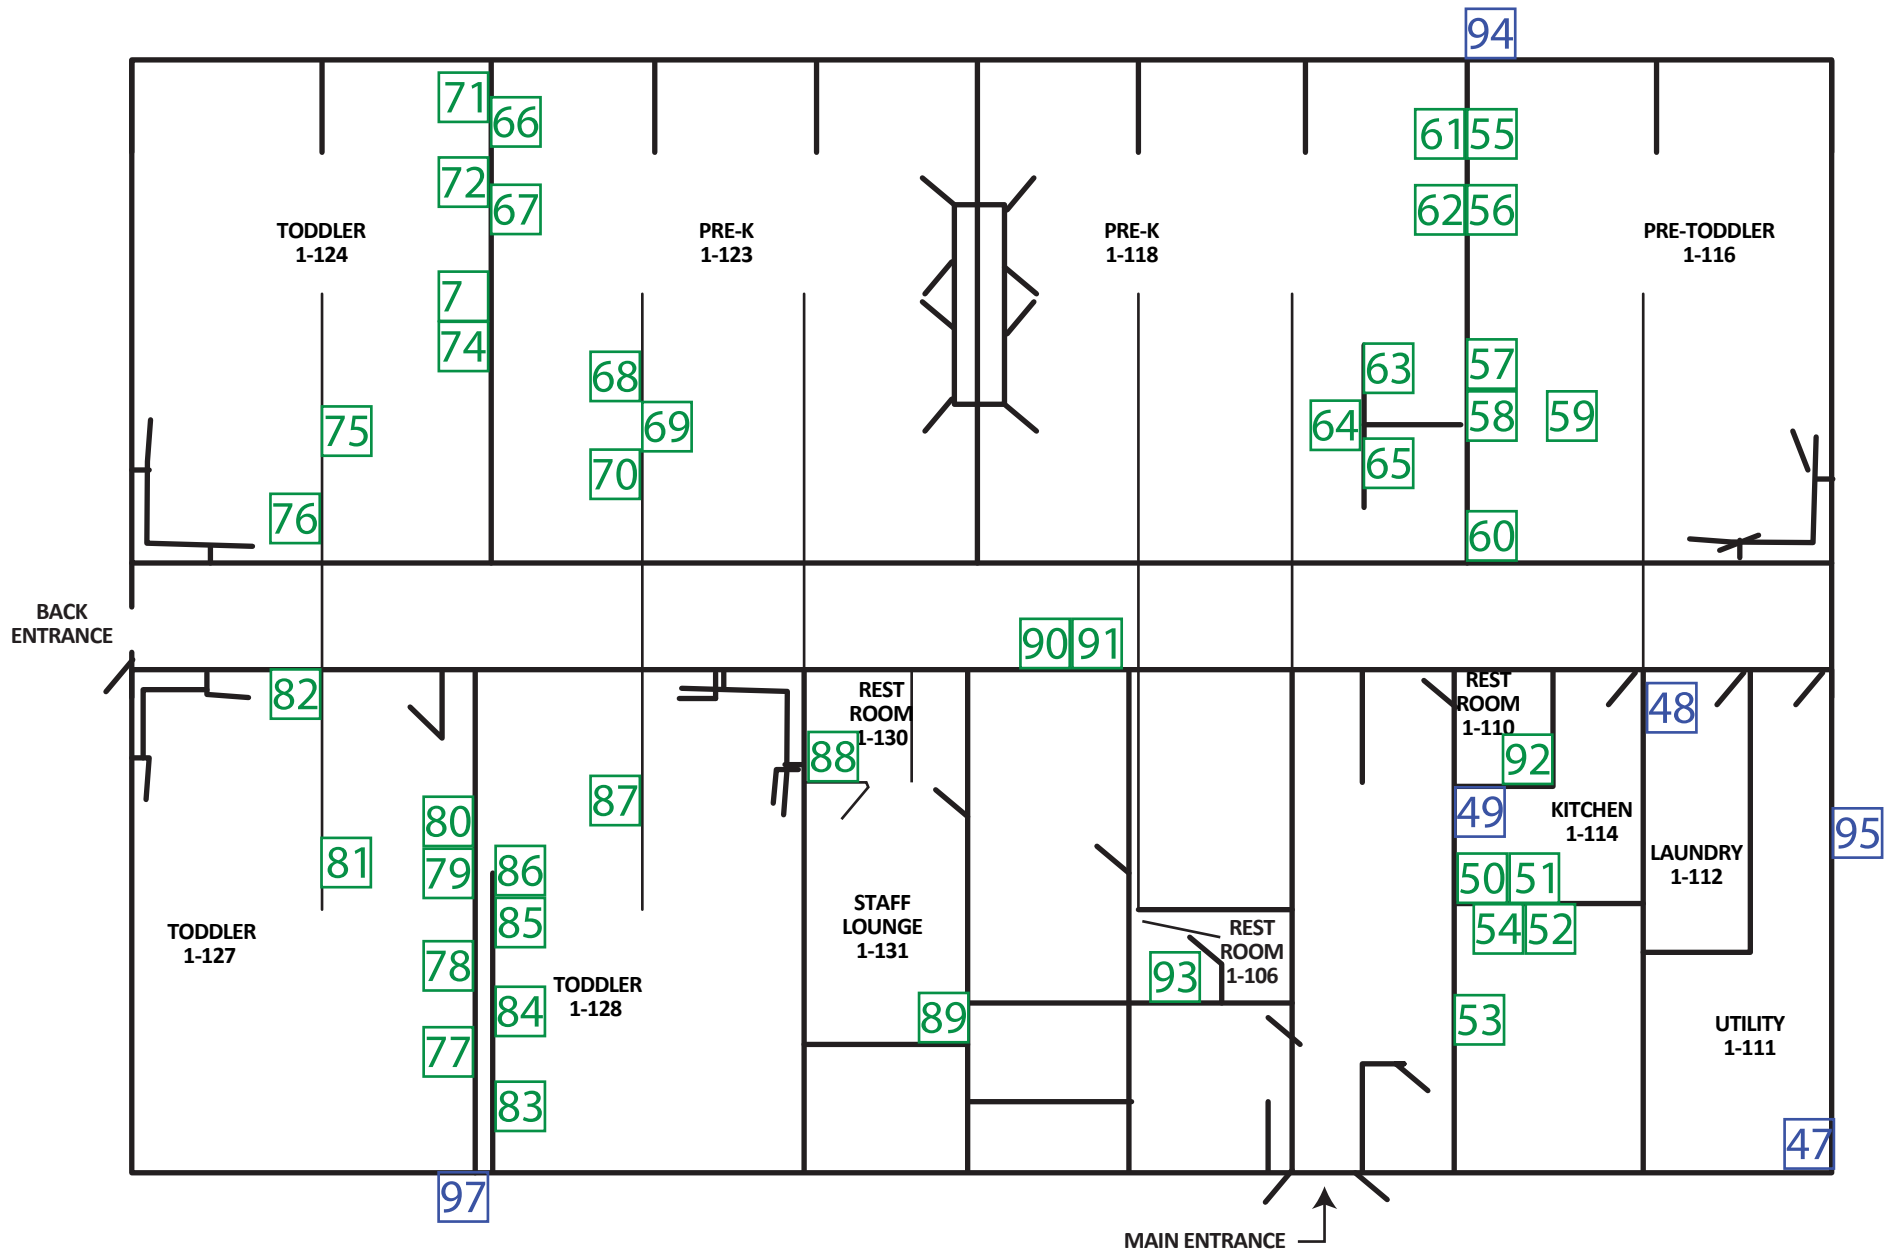
1 BUILDING 1641 - FLOOR PLAN

# Outlet numbers pertaining to the floor plan.  
 Red = Above 20 ppb  
 Green = Below 20 ppb  
 Blue = Not Sampled

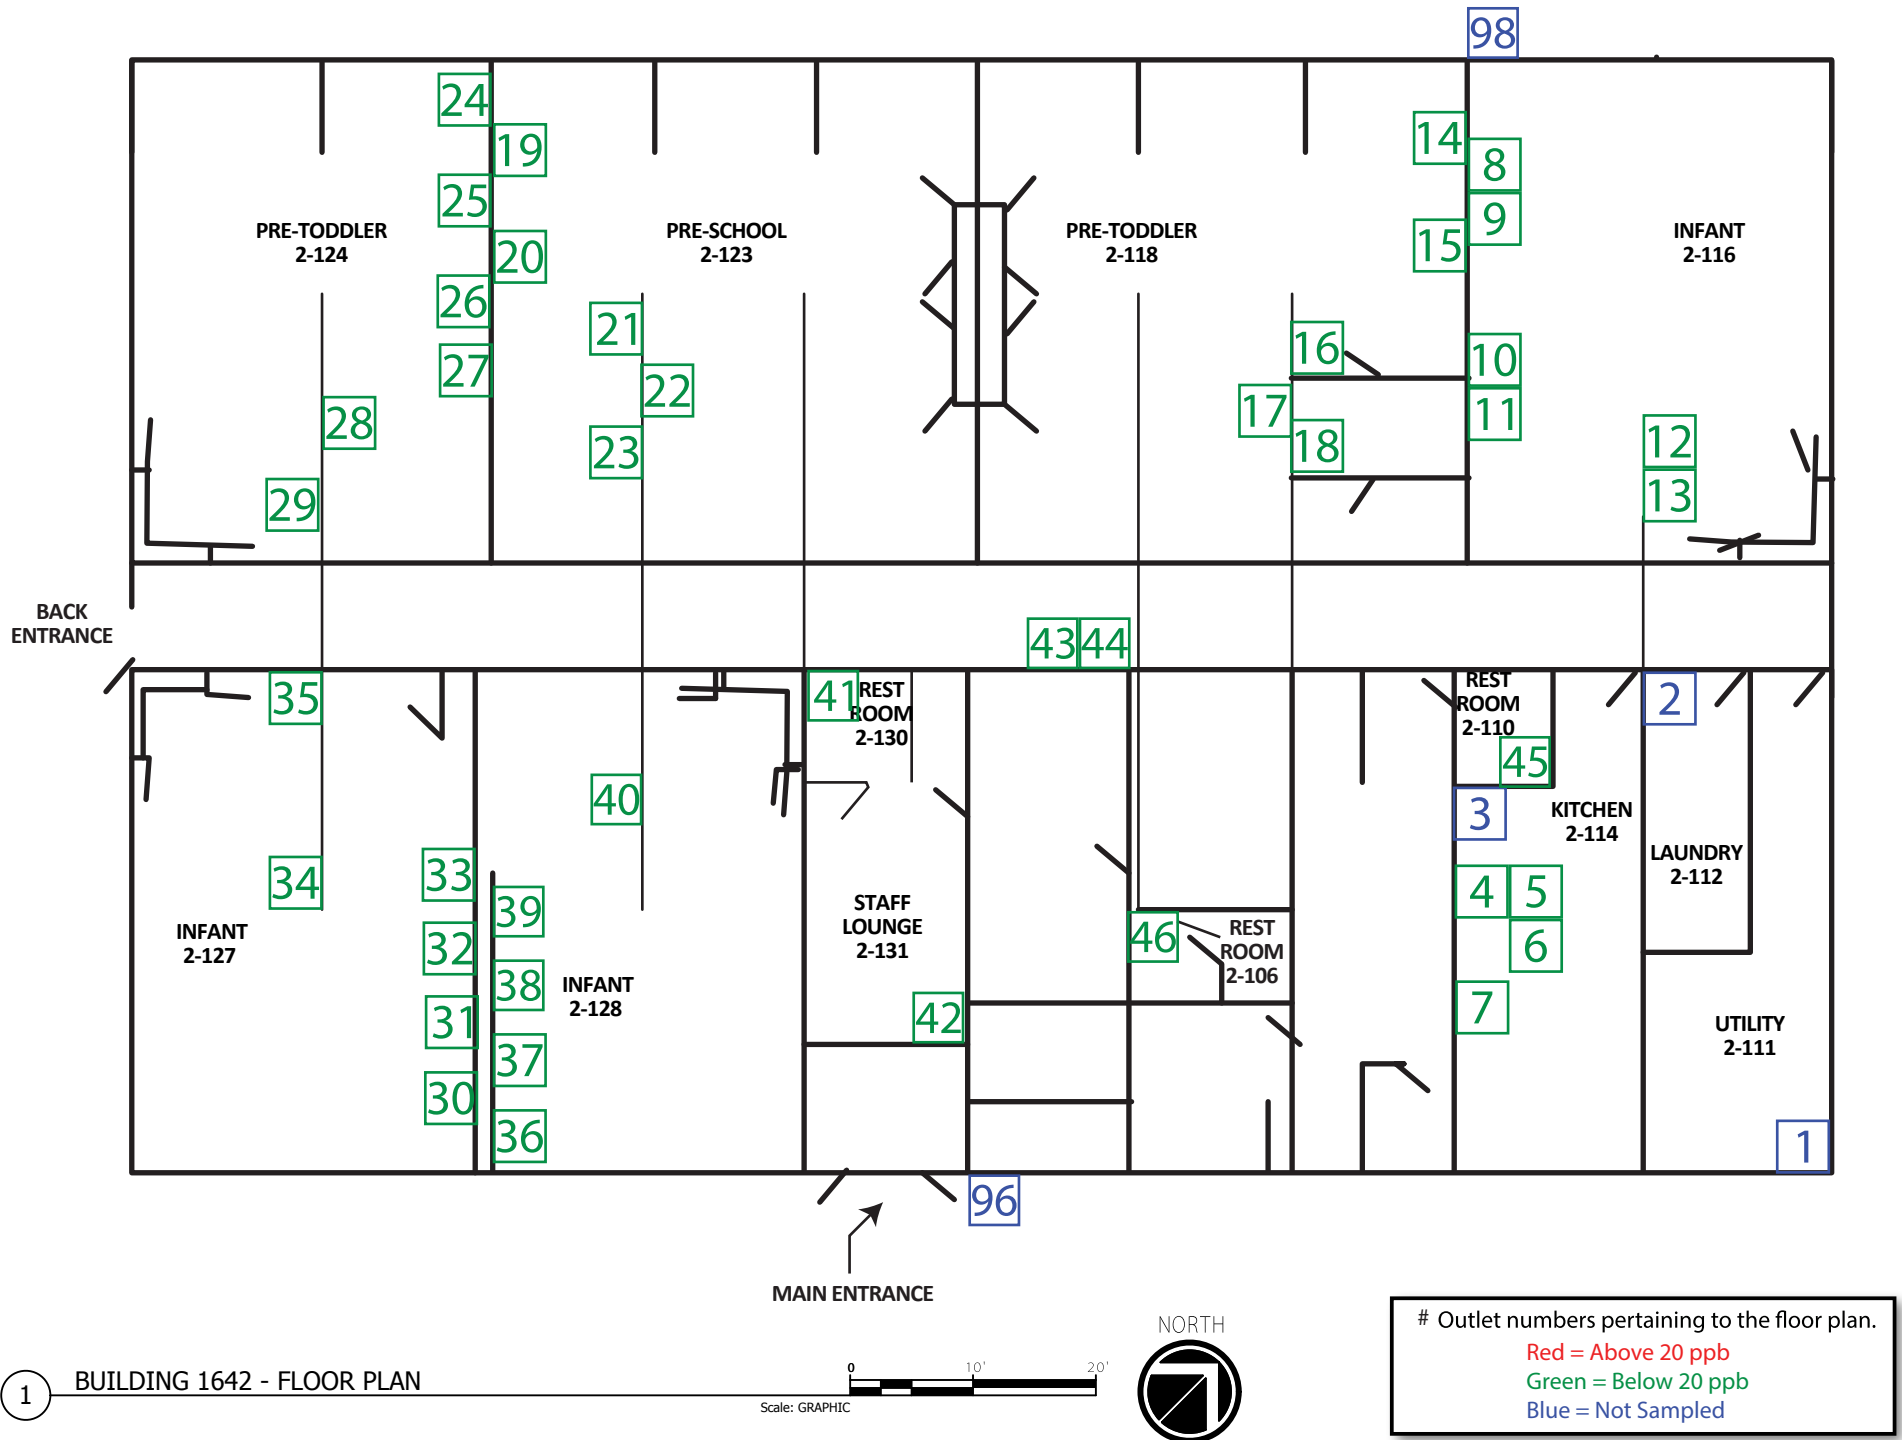
# Outlet numbers pertaining to the floor plan.

Red = Above 20 ppb  
Green = Below 20 ppb  
Blue = Not Sampled
