**Overview of Testing Results for Lead in Drinking Water
and Corrective Actions for
Joint Expeditionary Base Little Creek Child Development Center Annex (Building 3364)**

Overview of Results and Corrective Actions (September 2016)

JEB Little Creek, CDC, Annex Building 3364

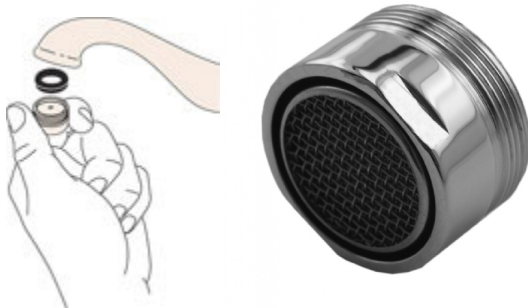
The two outlets that exceeded 20 ppb were hand washing sinks and are not used for drinking or cooking. These sinks were located in rooms 9 and 100. Follow-up sampling at these outlets was conducted after removing the faucet aerators. A **faucet aerator** (or tap aerator) is often found at the tip of modern indoor water faucets. Without an aerator, water usually flows out of a faucet as one big stream. An aerator spreads this stream into many little droplets, which helps save water and reduce splashing. However, the aerator and screen can trap debris which can accumulate lead.

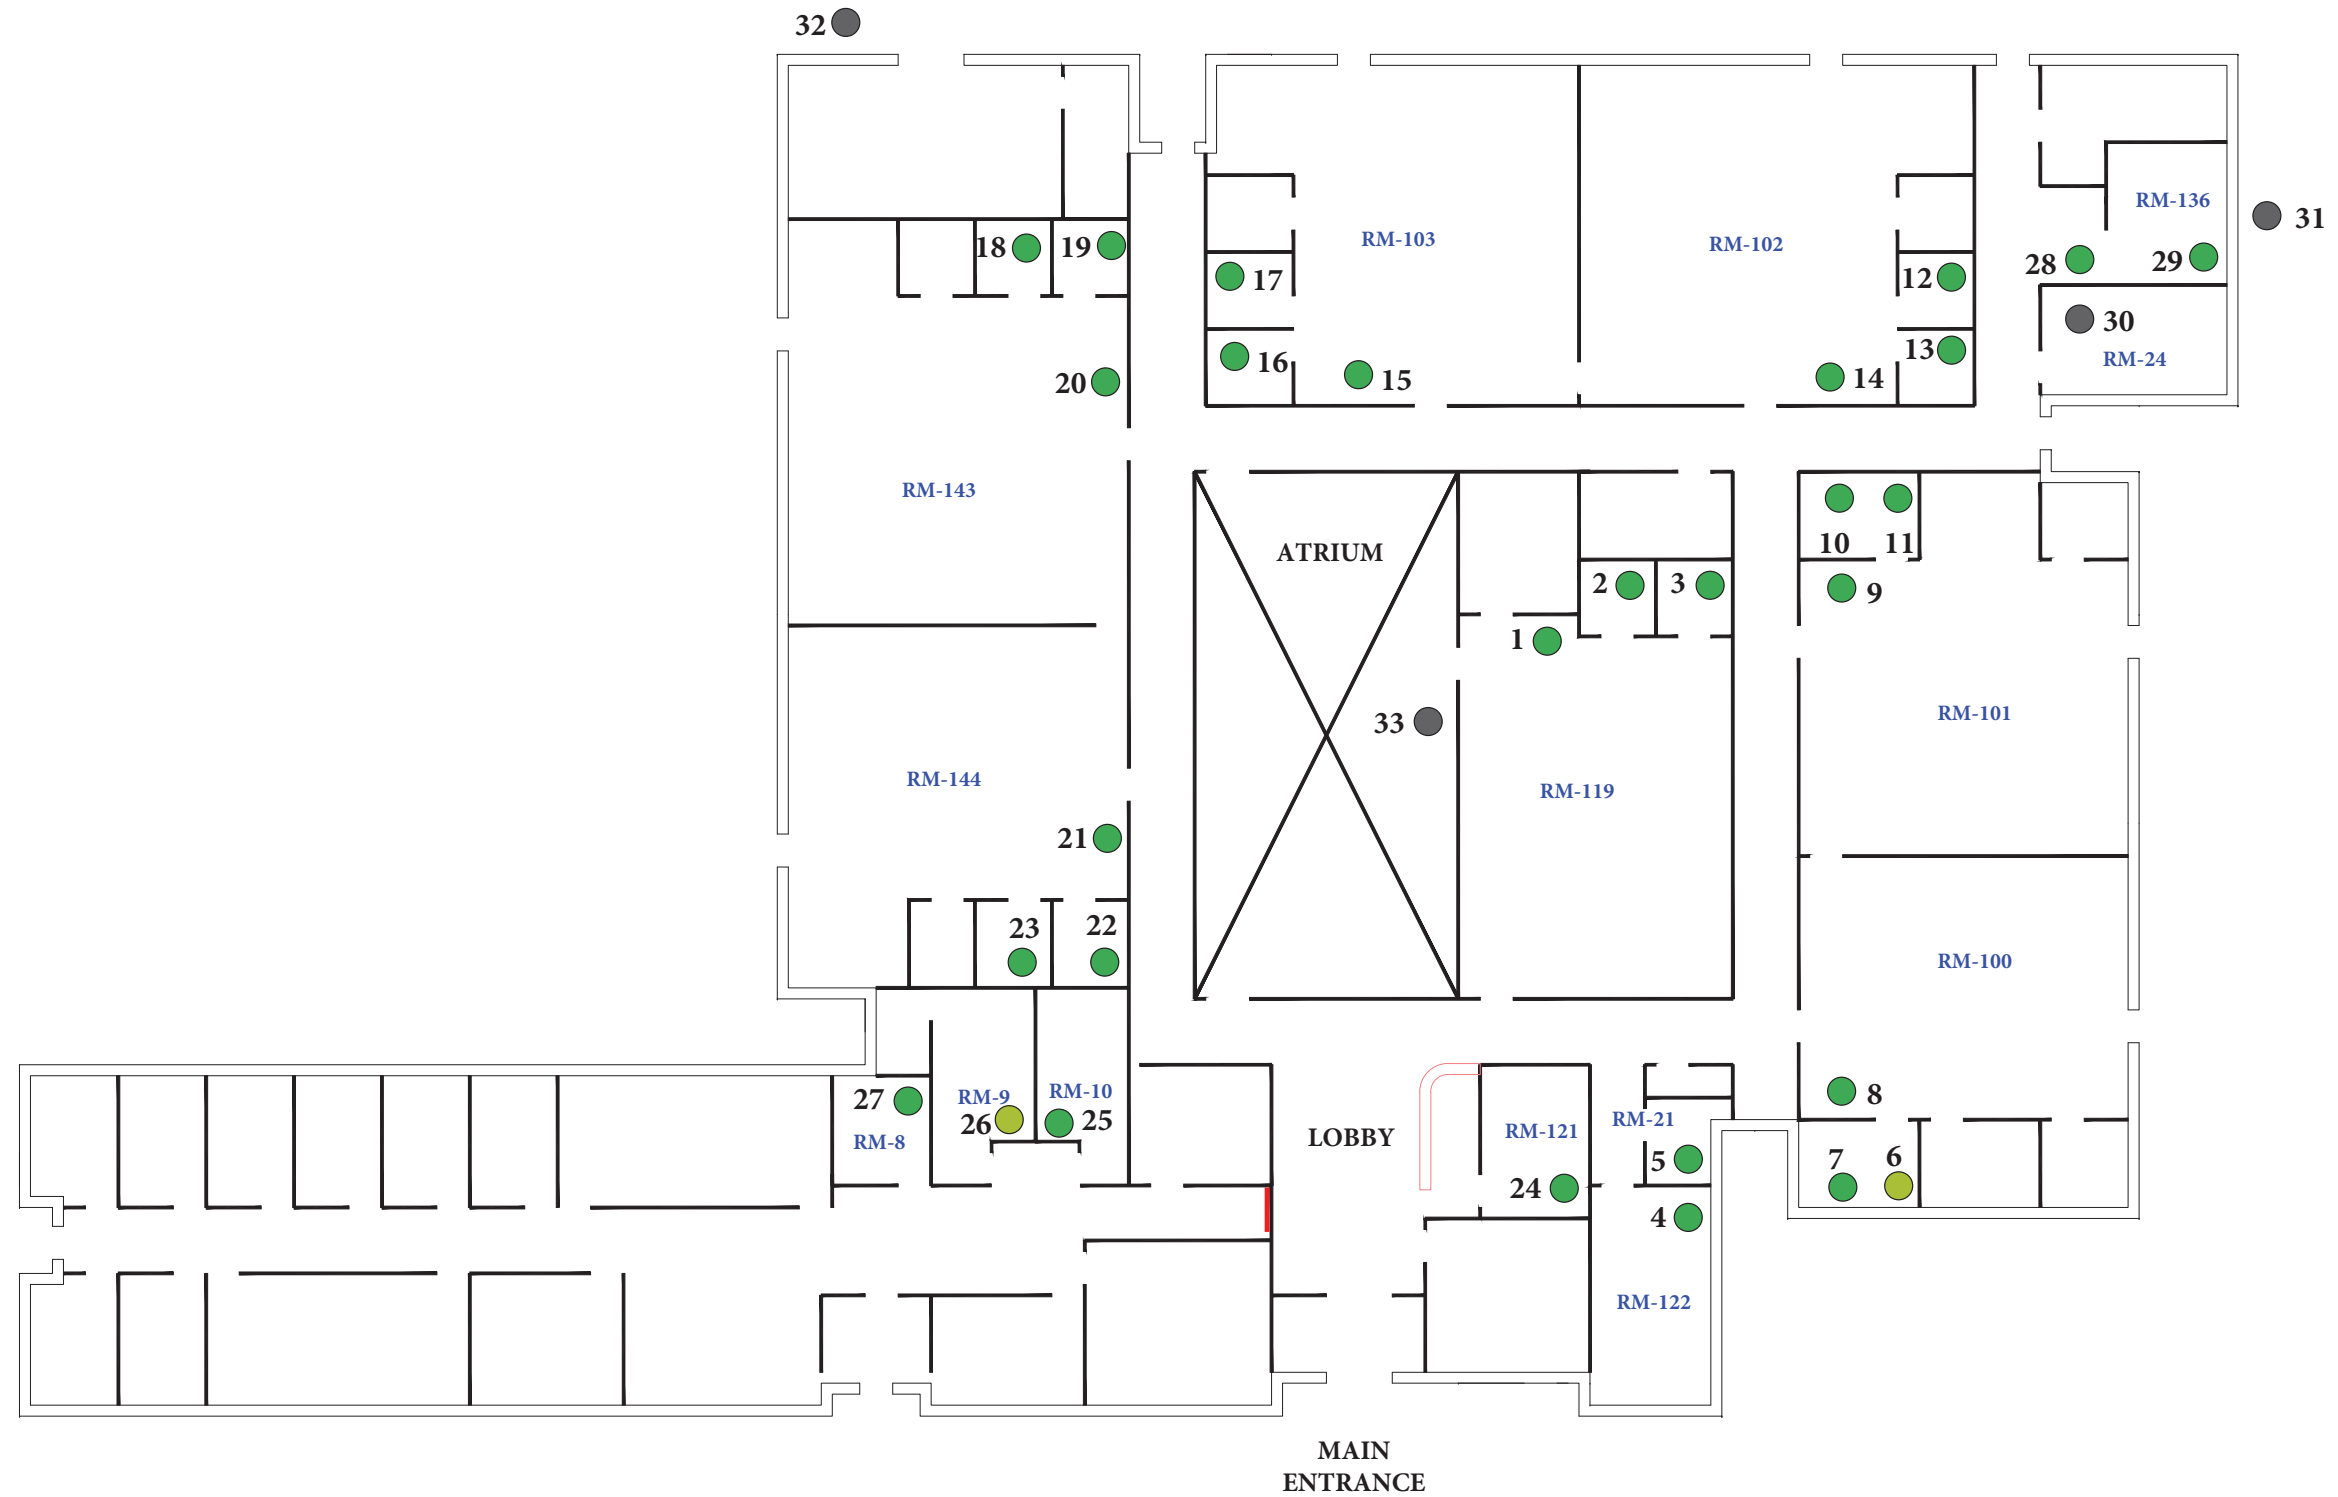
FIRST FLOOR PLAN

A floor plan of the JEB Little Creek CDC Annex has also been included to show the locations for the fixtures that initially exceeded 20 ppb.

After removing the faucet aerators, retesting showed that the sink in room 100 was below the EPA-recommended level, but the sink in room 9 was not. Further corrective measures (replacement of supply valves and supply piping) were implemented at the sink in room 9 and follow-up sampling indicates that this sink is also below the EPA-recommended level.

The *Corrective Actions* column describes actions that were taken to remediate the source of lead. In the event that fixtures or upstream piping are replaced (e.g., bathroom sinks in rooms 9 and 100), there are columns for sampling data that confirms that the corrective actions were successful in reducing lead below 20 ppb.
