**Overview of Testing Results for Lead in Drinking Water
and Corrective Actions for
Joint Expeditionary Base Little Creek CDC (Building 3432)**

Sample Summary Results Table
Priority Areas Lead Testing and Corrective Actions (September 2017)
JEB Little Creek Child Development Center, Building 3432

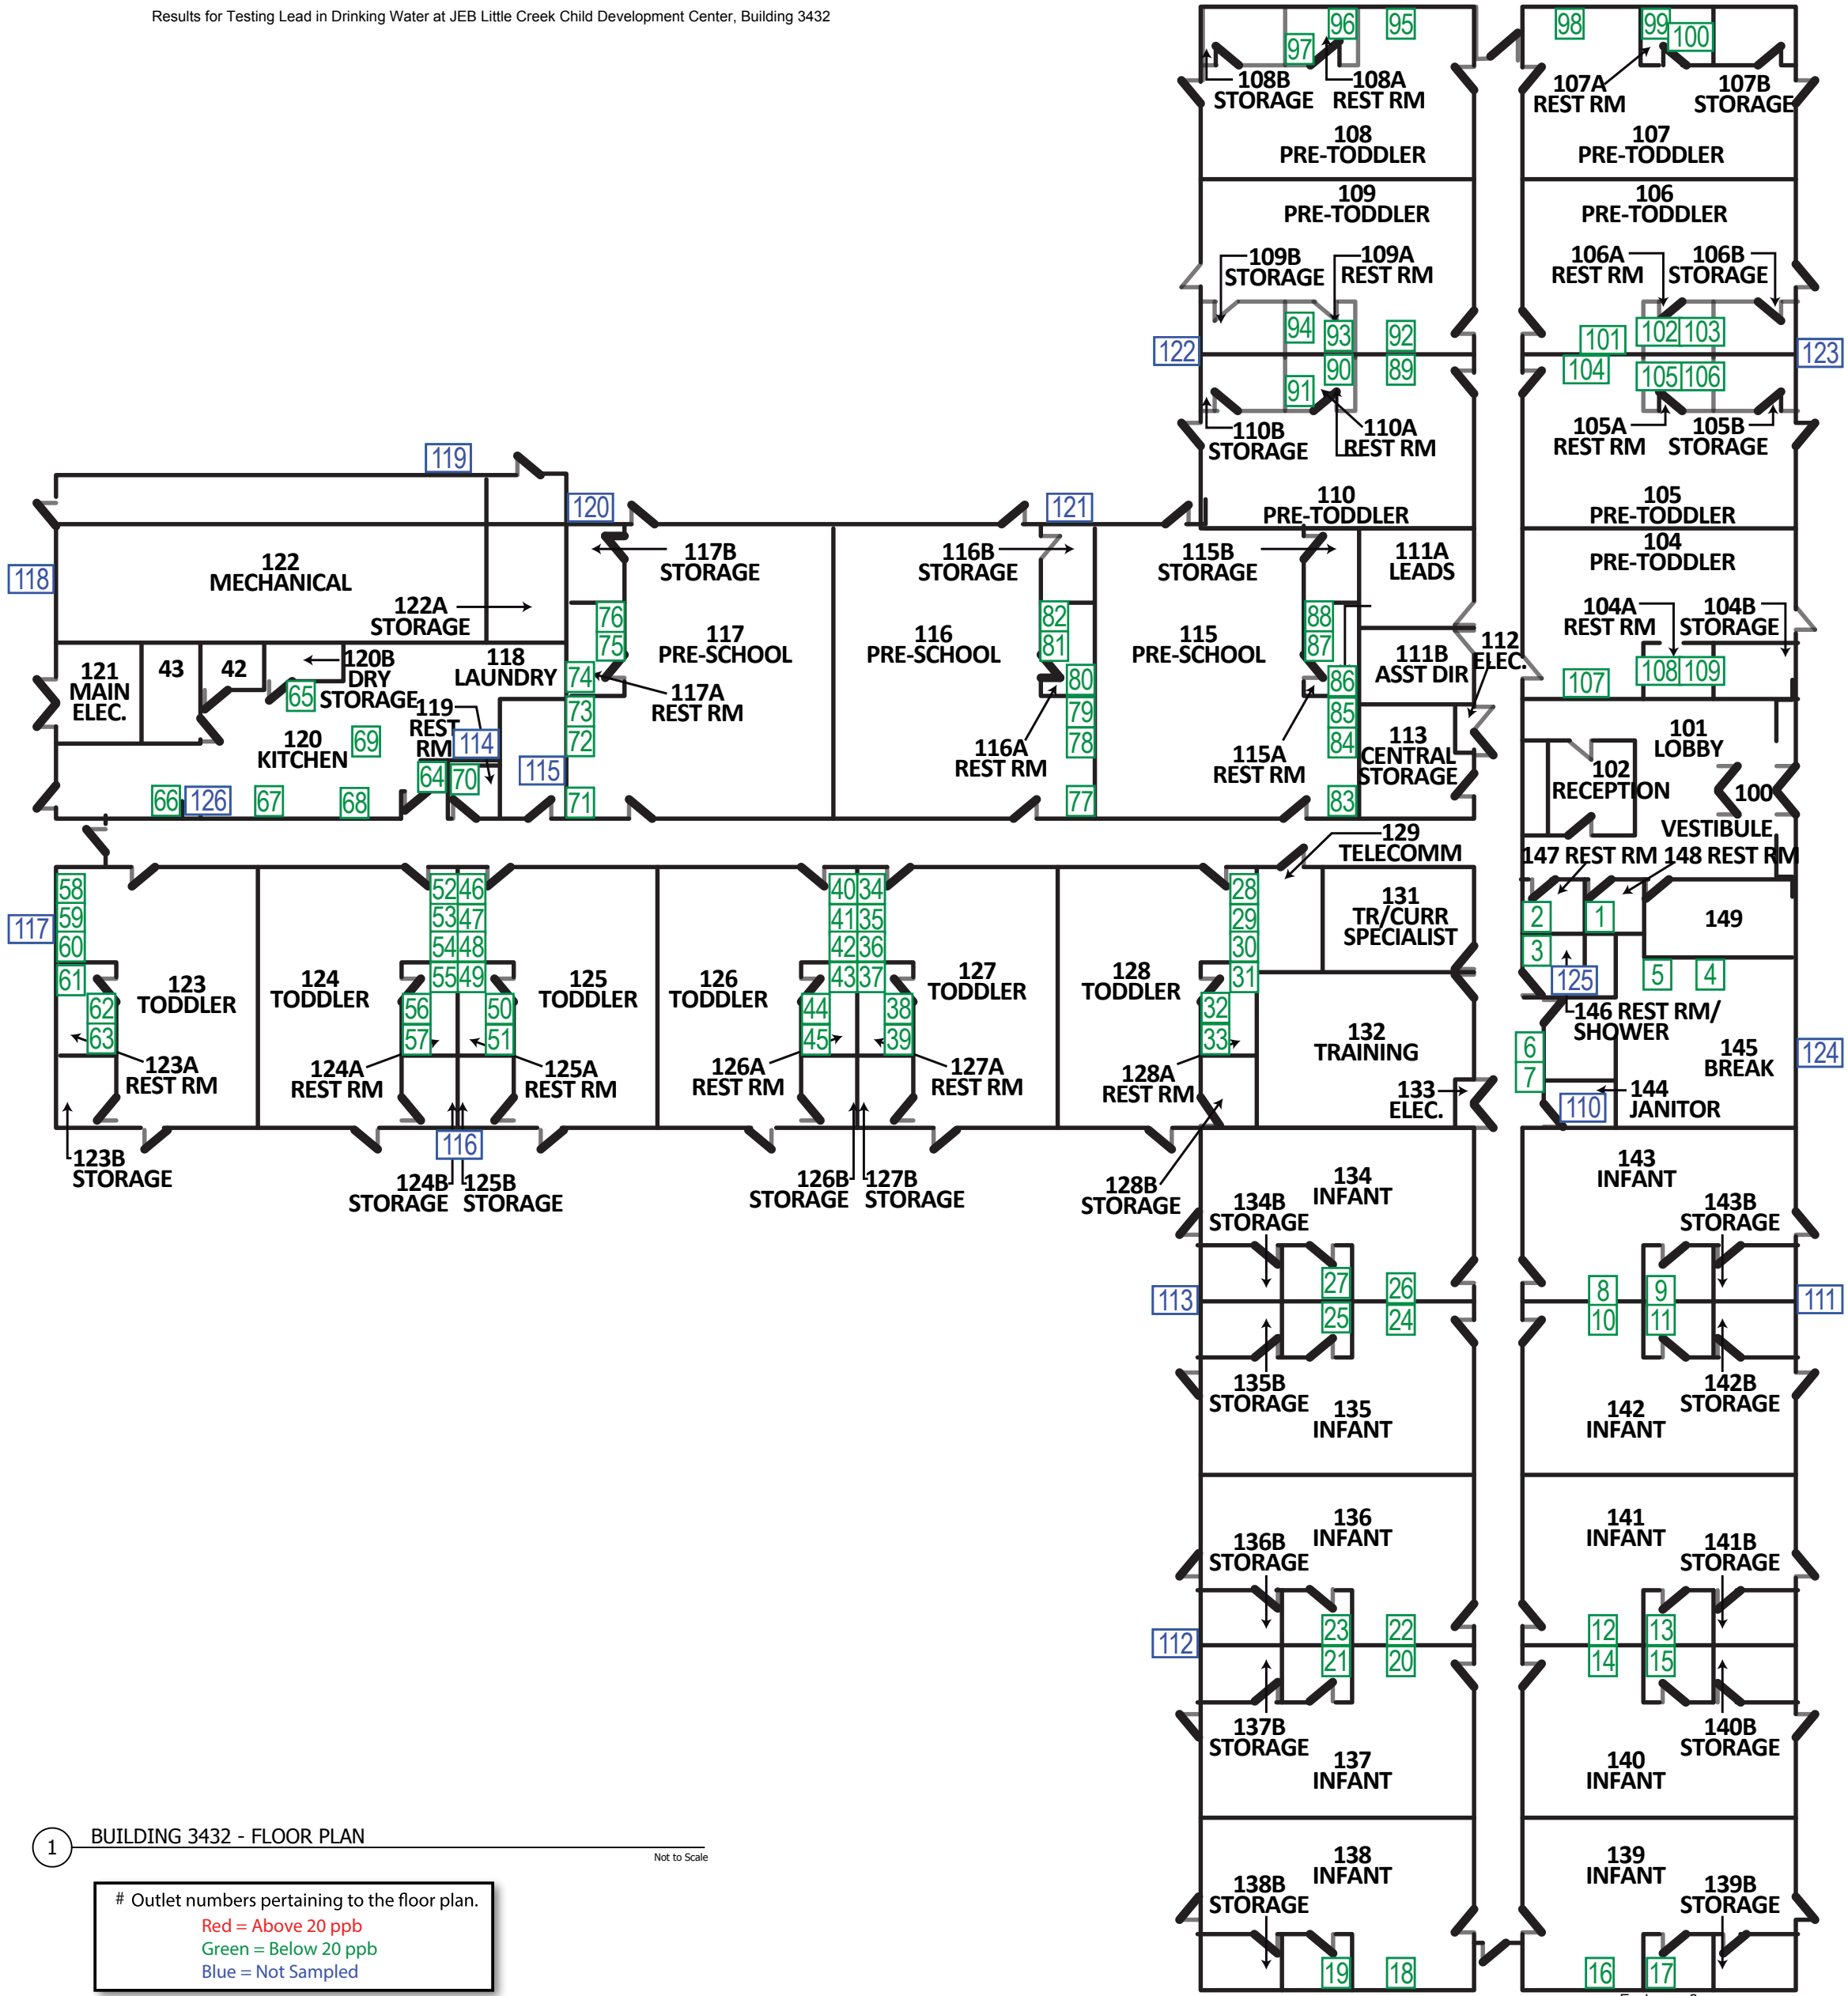
A floor plan of the JEB Little Creek CDC has also been included to show the locations of the fixtures that were sampled.

Outlet numbers pertaining to the floor plan.

Red = Above 20 ppb

Green = Below 20 ppb

Blue = Not Sampled
