**Subj:** JOINT EXPEDITIONARY BASE LITTLE CREEK-FORT STORY CHILD  
DEVELOPMENT CENTER, BUILDING 3432, DRINKING WATER RESULTS

**Encl:** (1) Test Results Overview  
(2) Sample Summary of Results  
(3) Floor Plan of JEB Little Creek Child Development Center, Building 3432

### Overview of Testing Results for Lead in Drinking Water for JEB Little Creek CDC, Building 3432

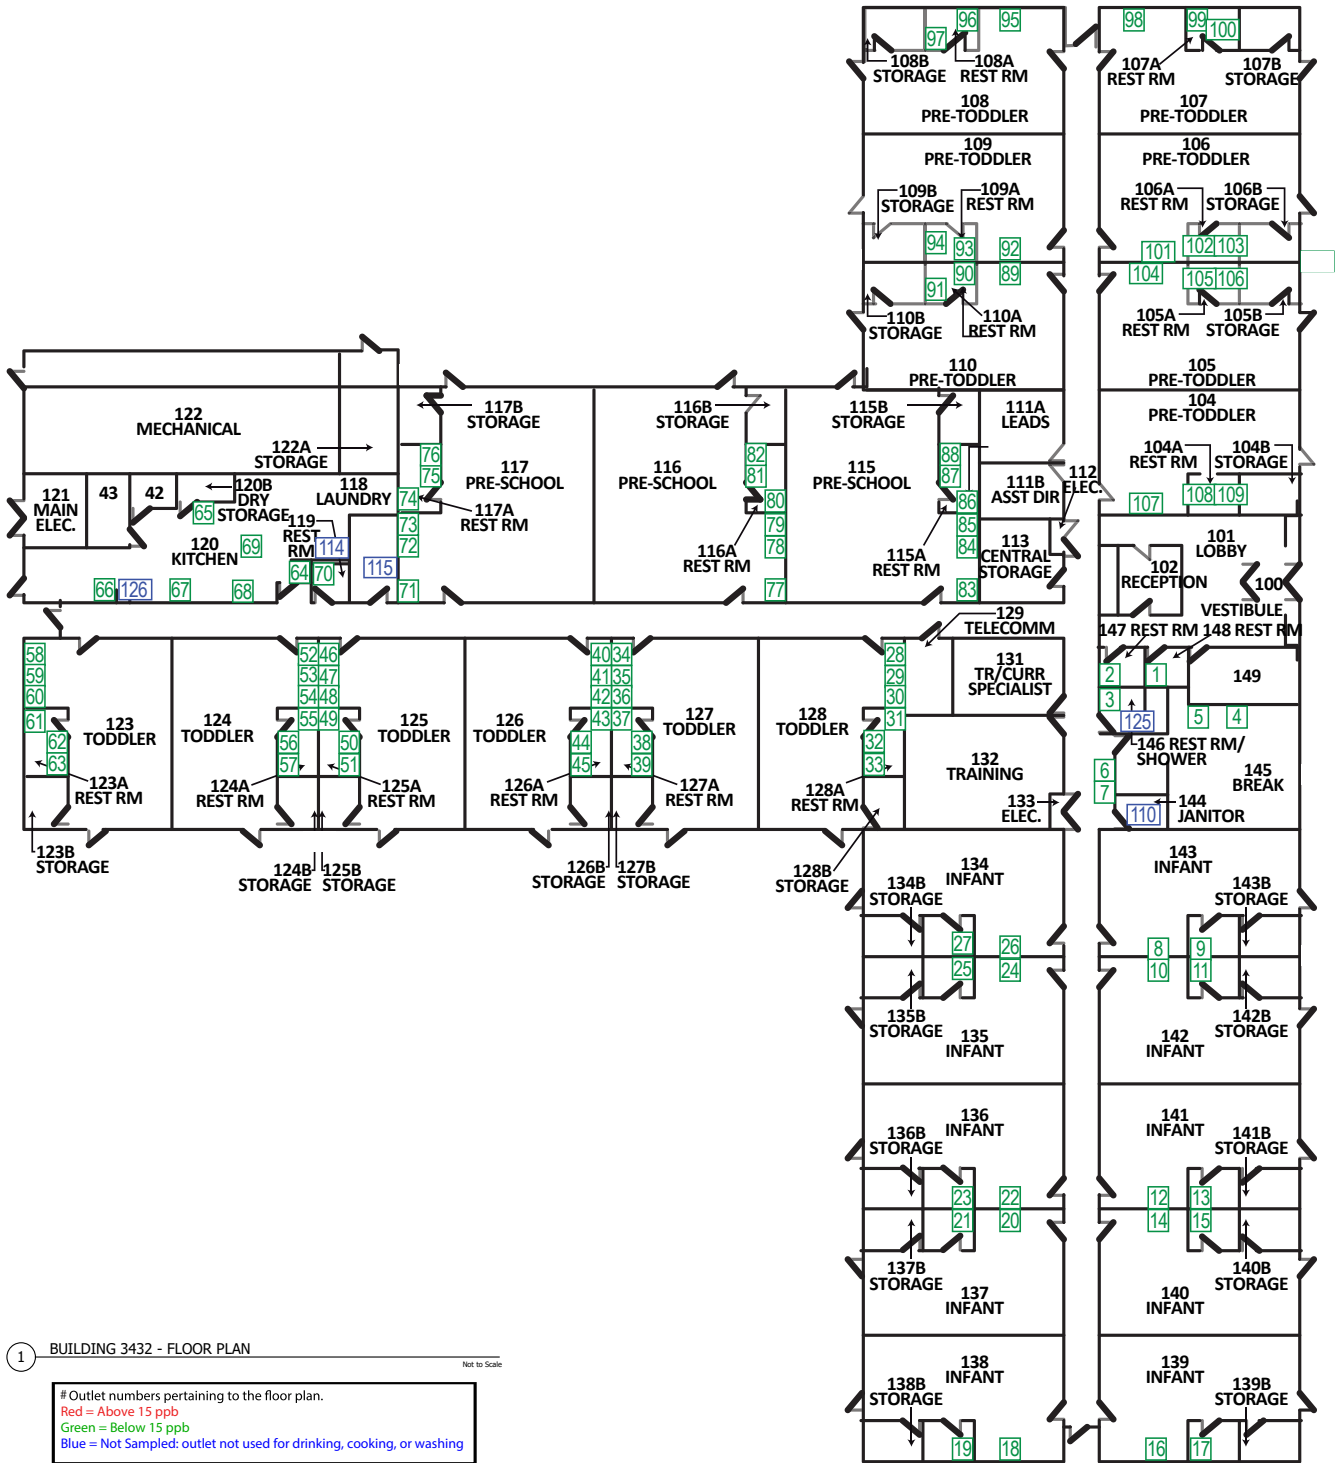
# Floor Plan of JEB Little Creek Child Development Center, Building 3432

3. In total 109 samples were taken and tested. An overview and summary of all the test results are included as Enclosures (1) and (2). A building floor plan indicating of the locations the samples were taken from is included as Enclosure (3). You can also see a hard copy of our water testing results at the JEB Little Creek CDC, Building 3432, which is open Monday to Friday from (0500 to 1800).

A floor plan of the JEB Little Creek CDC Building 3432 has also been included, as Enclosure (3), to show the locations of the outlets tested.
