Testing Results for Lead in Drinking Water for Norfolk Naval Shipyard, Scott Center Annex – Child Development Center – Building 1510

Priority Areas Lead Testing and Corrective Actions (November 2014)
Norfolk Naval Shipyard, Scott Center Annex, Child Development Center Building 1510

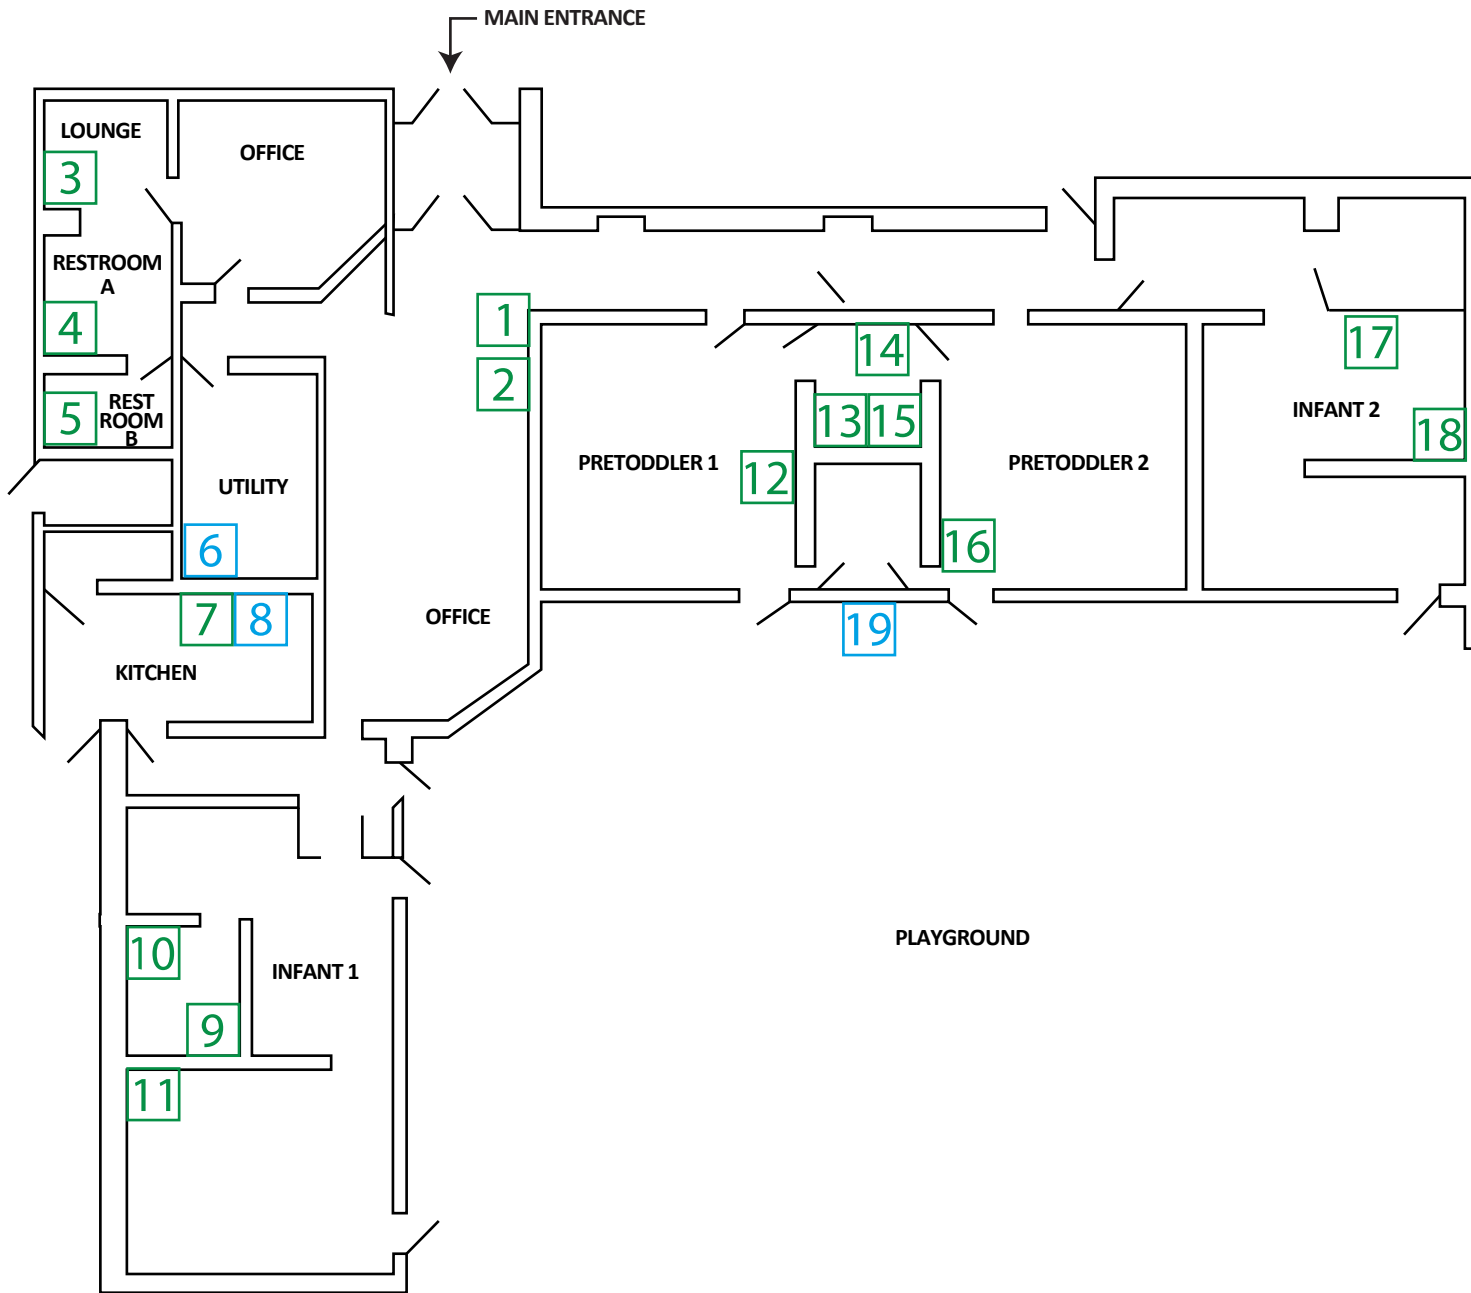
BUILDING 1510 - FLOOR PLAN

Outlet numbers pertaining to the floor plan.
 Red = Above 20 ppb
 Green = Below 20 ppb
 Blue = Not Sampled

No.	Type of Fixture	Location Description	Sampled?	Exceeded?
1	Water fountain (cooler)	Hallway	Yes	No
2	Water fountain (cooler)	Hallway	Yes	No
3	Kitchen sink for dishwashing, food preparation	Staff Lounge	Yes	No
4	High hand washing faucet	Restroom A	Yes	No
5	High hand washing faucet	Restroom B	Yes	No
6	Utility sink – not for drinking	Utility Room	No	N/A
7	Kitchen sink for dishwashing, food preparation	Kitchen	Yes	No
8	Dishwasher sprayer – not for drinking	Kitchen	No	N/A
9	High hand washing faucet	Infant Room 1	Yes	No
10	Low hand washing faucet	Infant Room 1	Yes	No
11	High hand washing faucet	Infant Room 1	Yes	No
12	High hand washing faucet for teeth brushing	Pre-Toddler Room 1	Yes	No
13	High hand washing faucet	Pre-Toddler Room 1	Yes	No
14	Low hand washing faucet	Pre-Toddler Room 1	Yes	No
15	High hand washing faucet	Pre-Toddler Room 2	Yes	No
16	High hand washing faucet for teeth brushing	Pre-Toddler Room 2	Yes	No

17	High hand washing faucet	Infant Room 2	Yes	No
18	High hand washing faucet	Infant Room 2	Yes	No
19	Hose outlet – not for drinking	Outside	No	N/A
